**- INSPECTION REPORT**  
**NATIONAL DAM SAFETY PROGRAM**

**WAR HORSE PROJECT DAMS**  
**PETROLEUM COUNTY, MONTANA**  
**MAIN DAM MT - 13      WEST DIKE MT - 3208**

**Christian, Spring, Sielbach & Associates**  
**Bozeman, Montana**

**July 1981**

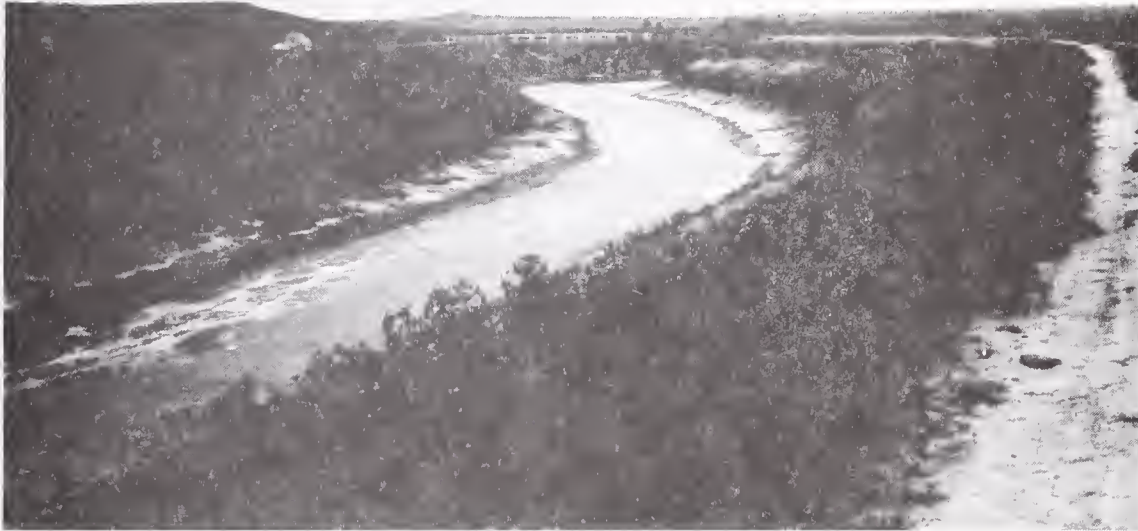
PHOTO 3  
County Bridge Across Canal  
Note: Channel Restriction

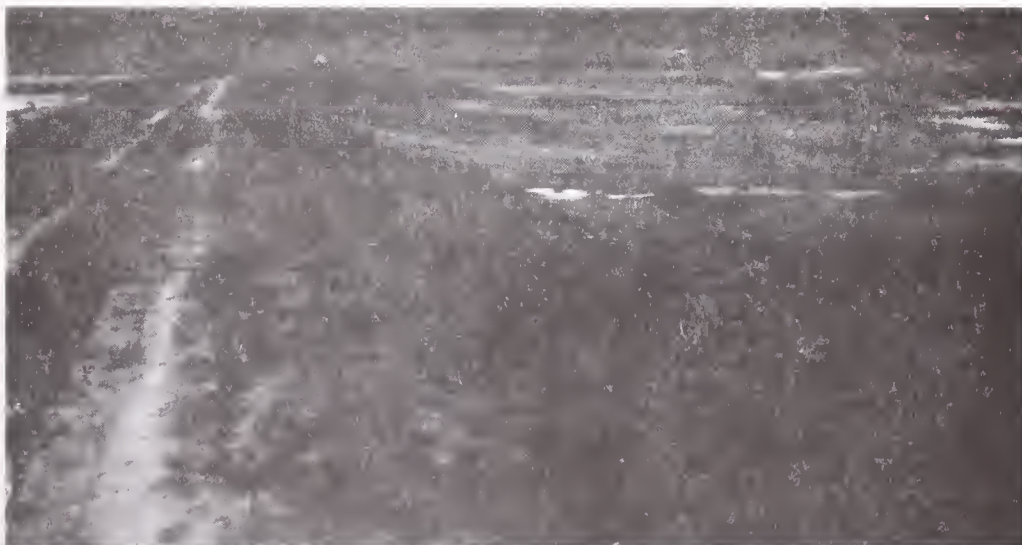
The downstream slope was not cracked or otherwise irregular, although some minor rilling was noted on the 2H to 1V slopes. Vegetative cover was sparse. (Photo 4) No seepage was observed or indicated along the slope.

PHOTO 4  
West Dike - Crest and Downstream Slope  
Note: White Areas Are Saline Seep

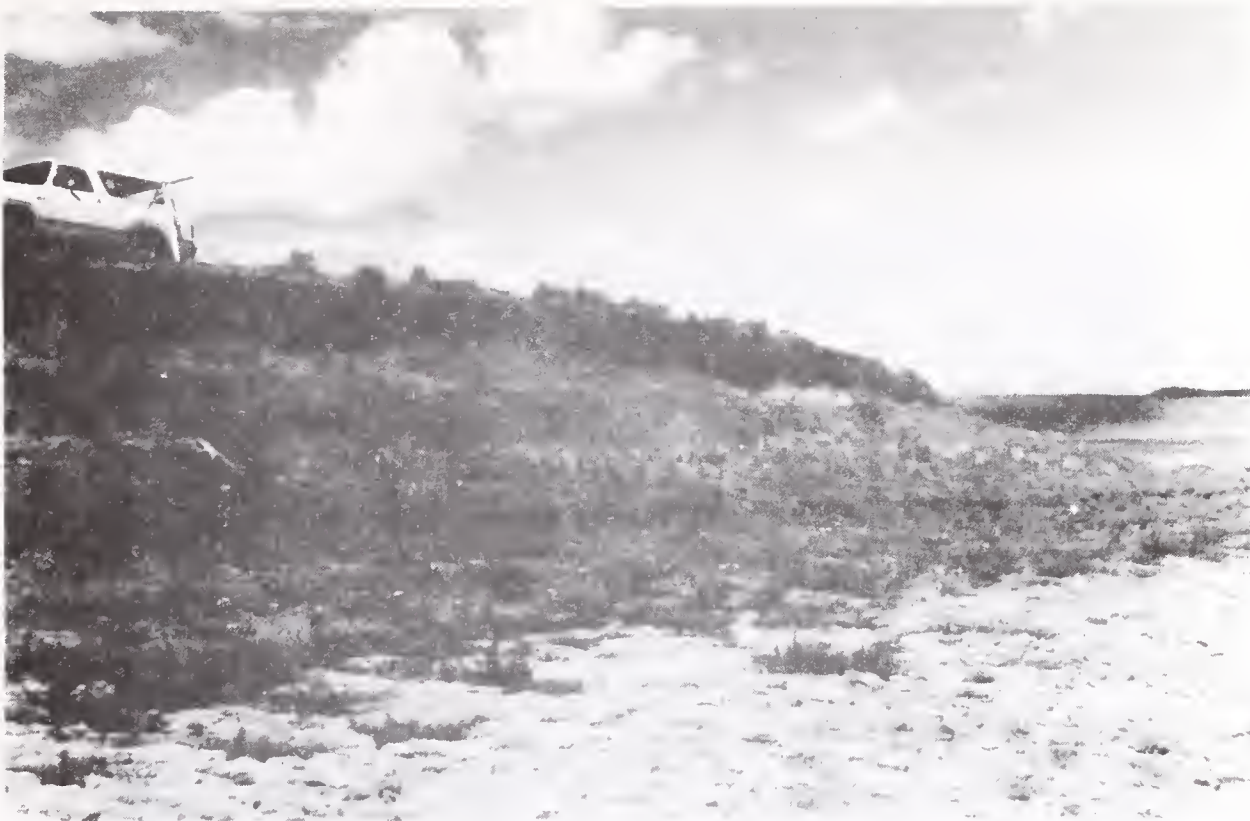
The upstream slope is deeply eroded due to wave action (Photos 5 and 6). This erosion has backcut the silt-clay slope to the vertical in the upper 3 feet of the embankment for a distance greater than 500 feet along the dike. No slope protection was observed.

PHOTO 5  
West Dike-Upstream Slope  
Note: Wave Erosion

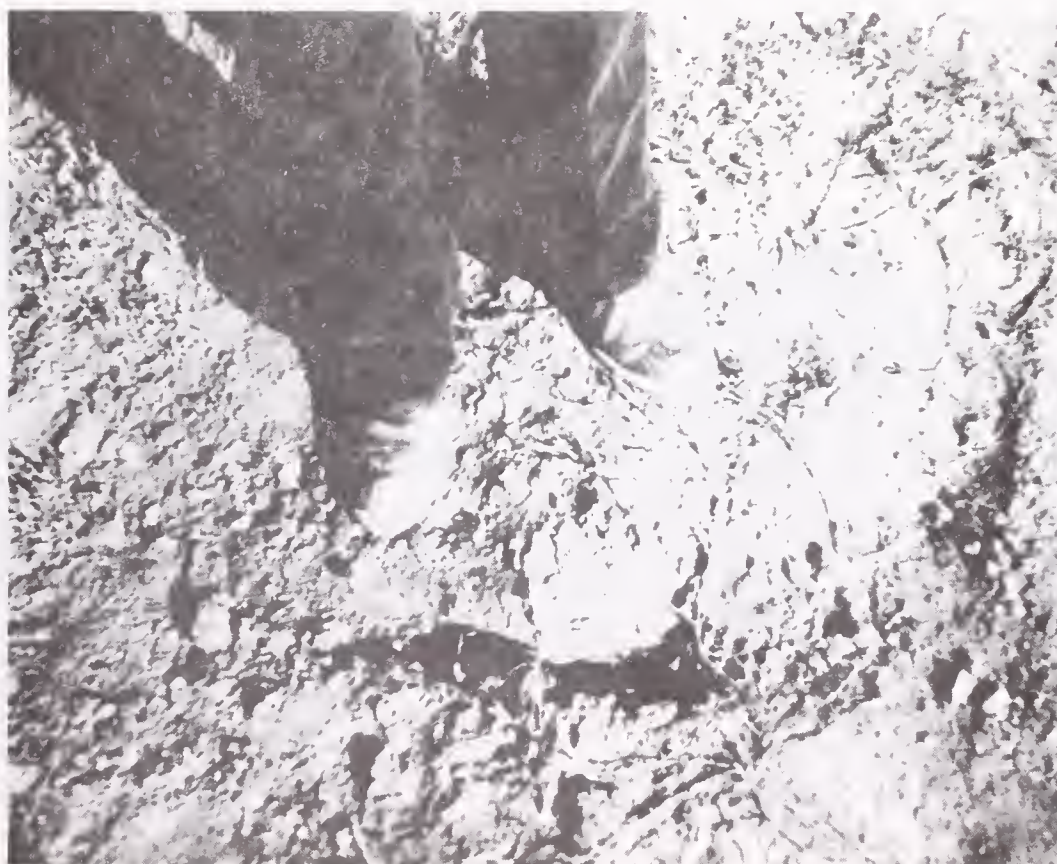
The profile along the dam crest has numerous irregularities associated in part with the longitudinal cracking observed over much of the crest length (Photo 8). This cracking may be related to the high plasticity (high volume change potential) of embankment soils. These soils, examined and sampled along the surface of the dam crest, were clayey silts and weathered shale. Index testing on two random samples indicated Unified System Classifications of CH and CL. The crest of the dam does not have a surface maintained for vehicular traffic; some minor rutting has resulted.

Longitudinal cracking was observed intermittently along the dam crest. The continuity and depth of this cracking could not be determined, but could be several feet deep.

PHOTO 8  
Typical Longitudinal Crack in Main Dam Crest

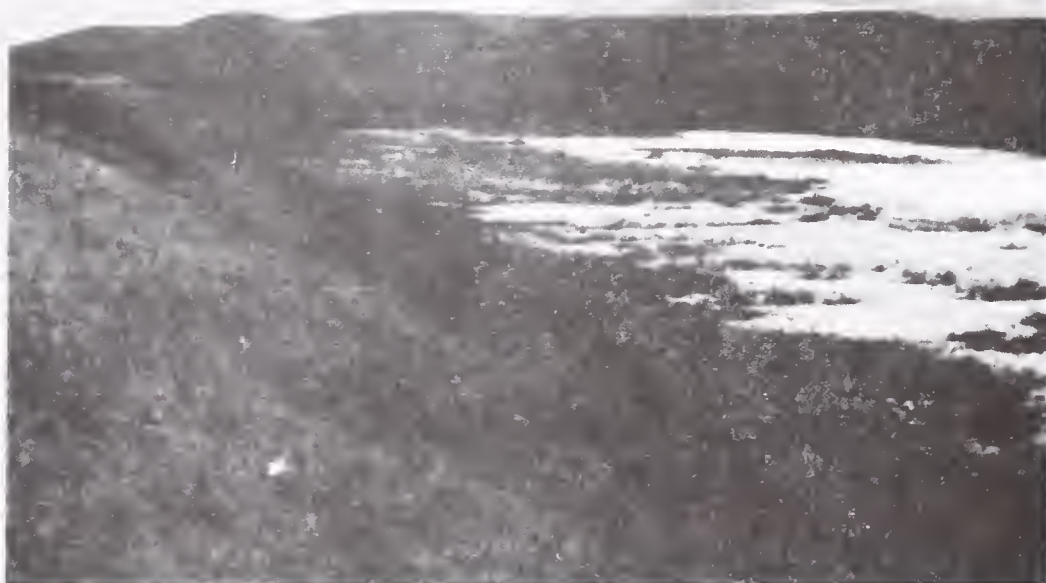
PHOTO 9

Extensive areas of saline seep were noted immediately downstream of the embankment (Photo 9). Such deposits were typical in the valley both up and downstream of the dam. The downstream channel is obstructed by silt deposits. Erosion around the lake inlet to the outlet works is probably the source of this material.

Main Dam - Downstream Slope

Note: White Saline Areas at Right

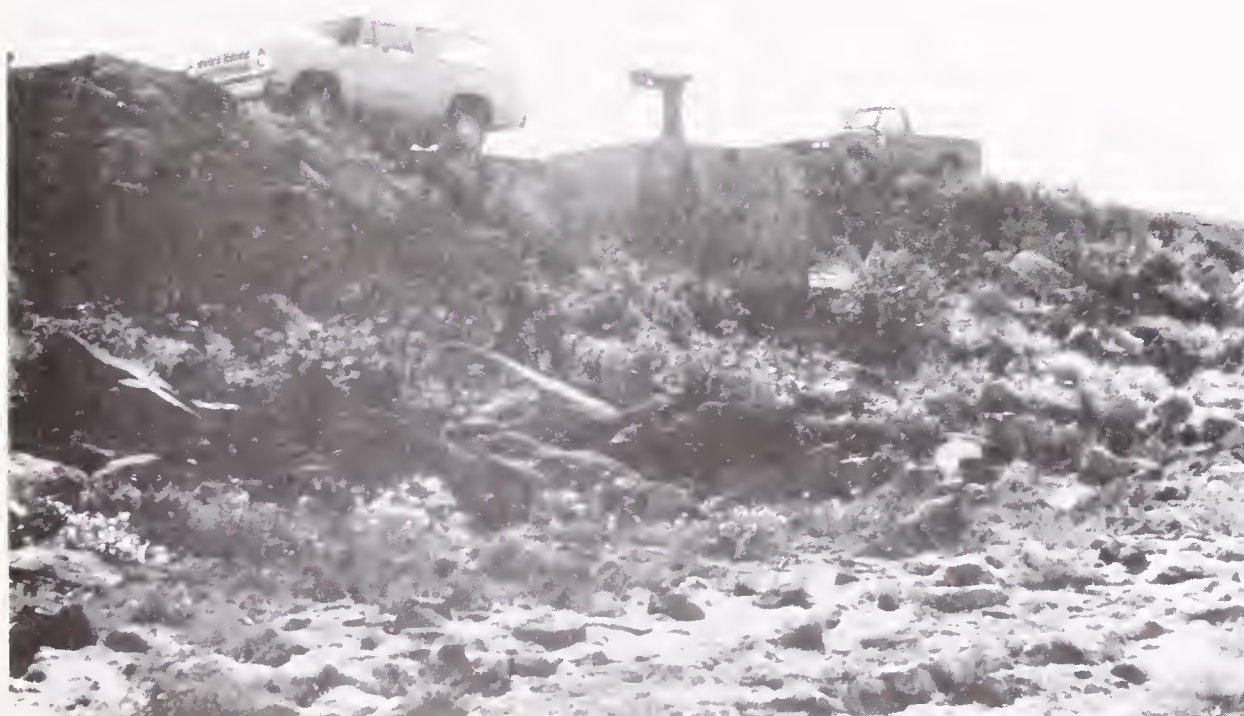
PHOTO 10

Upstream erosion along the dam has removed approximately 3 to 6 feet of embankment material from around the turnstile housing and platform of the intake structure. This loss of ground does not appear to have caused settling, tilting, or other surficial damage to the structure (Photo 10).

Outlet Works Control Tower and Upstream Face

Note: Erosion Behind and Right of Tower

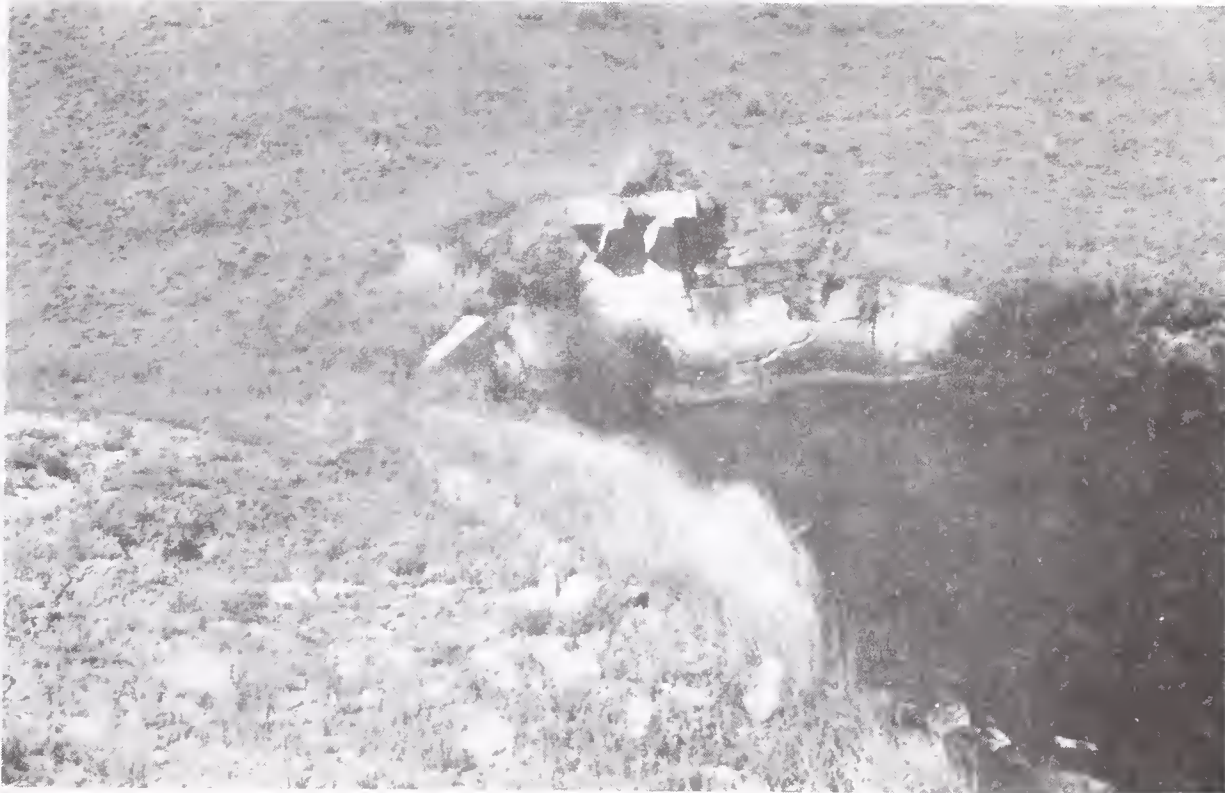
The inlet pipe from the reservoir to the gate control tower was under water and could not be inspected. Concrete in the gate control tower, which was repaired in 1971 appeared to be in fair condition. The gate lift mechanism is very difficult to operate, and reportedly has been for several years. The outlet pipe from the control tower to the outlet box appeared to be in fair condition, although some minor cracking of the plastic mortar lining which covers the entire length of the outlet works was noted, and may be the result of continuing settlement of the outlet works. Exposed

concrete in the outlet basin is in generally poor condition due to cracking and spalling.

PHOTO 11  
Outlet Works Discharge  
Note: Deteriorating Concrete

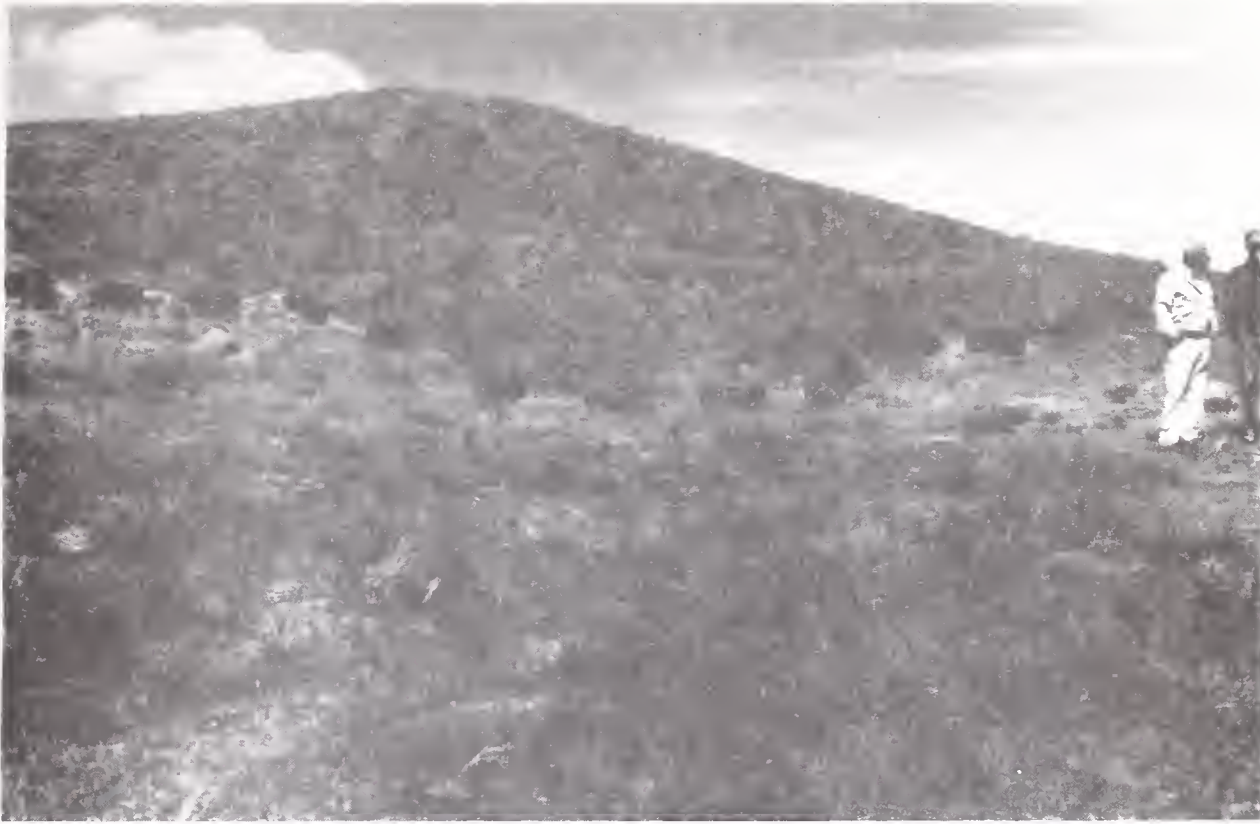
The "emergency" spillway for this project is a breach in the low bank of the supply canal from Buffalo Creek. The breach was installed as an emergency measure in May, 1979, to control reservoir levels so that emergency repairs on the wave-eroded upstream slope of the embankment could be accomplished.

The breach will function as a primary spillway when reservoir elevations provide sufficient head to overcome competing heads caused by flows toward the reservoir in the Buffalo Creek supply canal. Because the breach crest is subject to erosion, and its function as an "emergency" spillway is questionable in routing extreme flood events, it is our opinion that a more positive means should be installed in the project to control selected maximum normal reservoir elevation, and to bypass excess flood flows in a safe manner.

PHOTO 13  
Emergency Spillway/Canal Breach  
Outlined in Black for Clarity

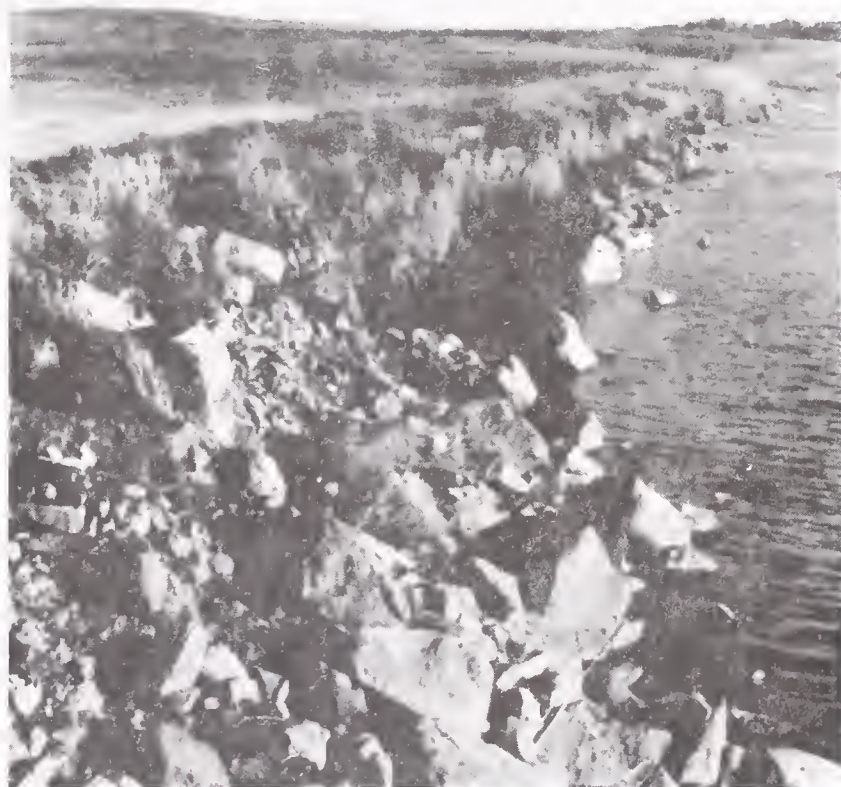
PHOTO 15

On Sunday, May 13, 1979, large wind generated waves severely eroded the upstream face near the outlet works. (Photos 15 & 16) The combination of higher than normal reservoir levels and very high winds caused the waves to break above the riprap protection. MDNRC personnel and several local residents excavated a breach in the supply canal from Buffalo Creek and used a paddle scraper and dozer to implement emergency repairs. A temporary breakwater was constructed using old telephone poles to better protect the repaired area. A metal arch pipe was installed through the bank of the Ford's Creek supply canal to further lower the reservoir (This pipe has since been removed). The final MDNRC report that was available recommended rebuilding the embankment with more suitable materials and construction methods, add riprap to the entire upstream face, construct a permanent spillway in the supply canal from Buffalo Creek, check the outlet conduit for damage. Current embankment conditions are covered in sections 2.3 and 3.1.5-7.

MDNRC Photo of 5/79 Wave Erosion-Looking South

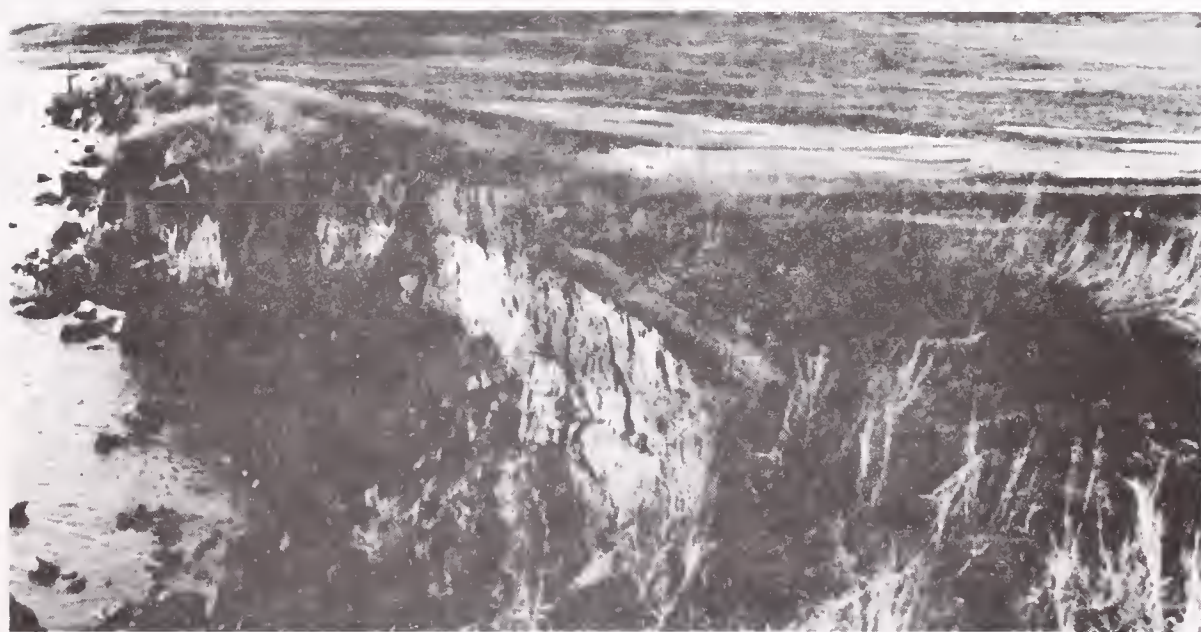
PHOTO 16

MDNRC Photo of 5/79 Wave Erosion-Looking North

Note: Water Level at Control Tower At Left,  
Also, Compare Crest Width To That In Photo 7
